## **ИССЛЕДОВАНИЕ ПРОЦЕССА ДЕФОРМИРОВАНИЯ ПРИБОРТОВОГО МАССИВА КАЧАРСКОГО КАРЬЕРА НА ОСНОВЕ ВНЕДРЕНИЯ ИННОВАЦИОННЫХ ТЕХНОЛОГИЙ**

**Цель.** Исследование устойчивости прибортовых массивов Качарского карьера, сложенных неоднородными, слоистыми, скальными и сильнотрещиноватыми горными породами путем разработки и совершенствования методики проведения инструментальных маркшейдерских наблюдений для предотвращения опасных деформаций и обеспечения безопасности при ведении горных работ.

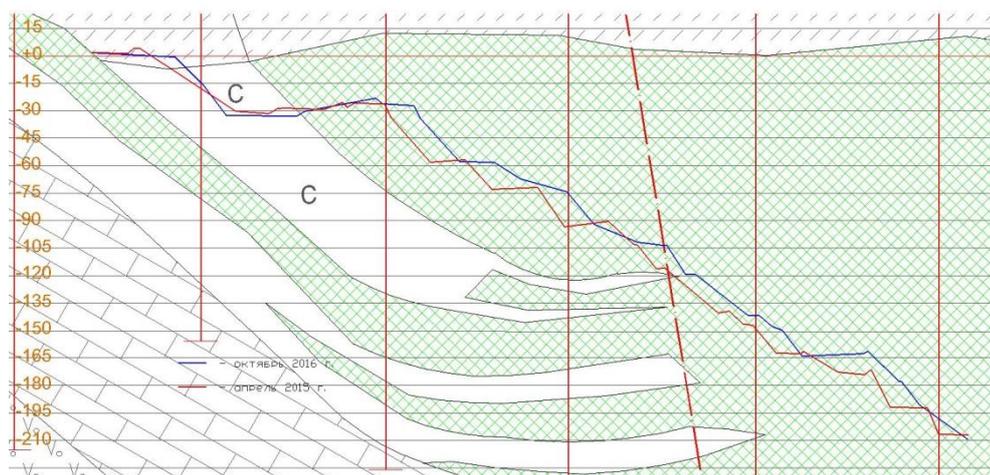
Рис. 2. Геологический разрез по линии XXIII

На геологическом разрезе XXIII и на локальных разрезах, построенных на оползневом участке, прослеживается наличие потенциальной поверхности скольжения, которая проходит по контакту метасоматитов и рудного тела (рис. 2, 3).

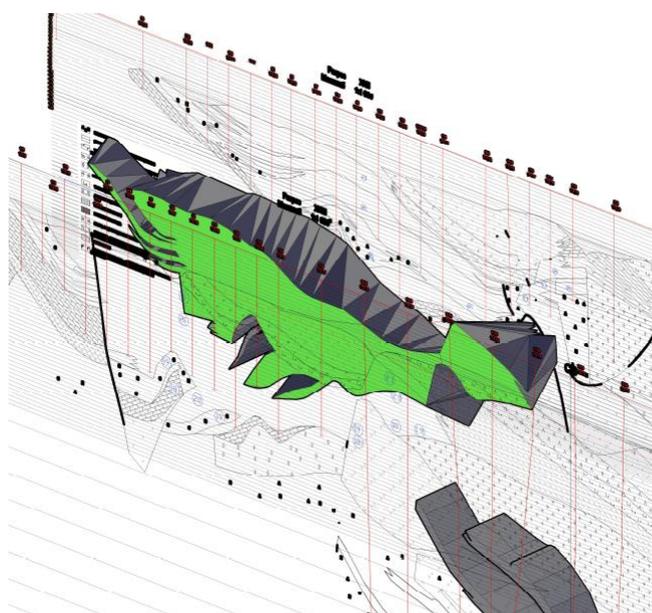
Рис. 3 Построение 3D модели для выделения горных пород с низкими прочностными характеристиками и рудного тела в пространственных координатах

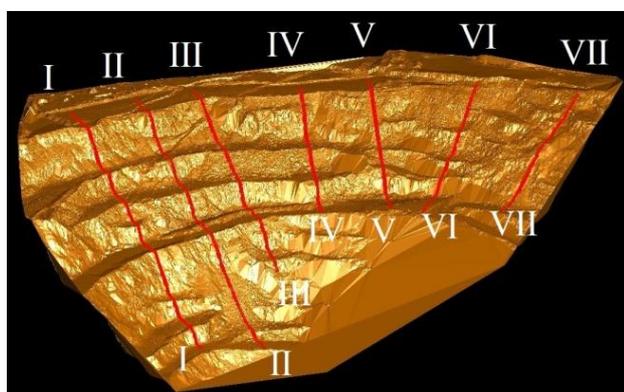
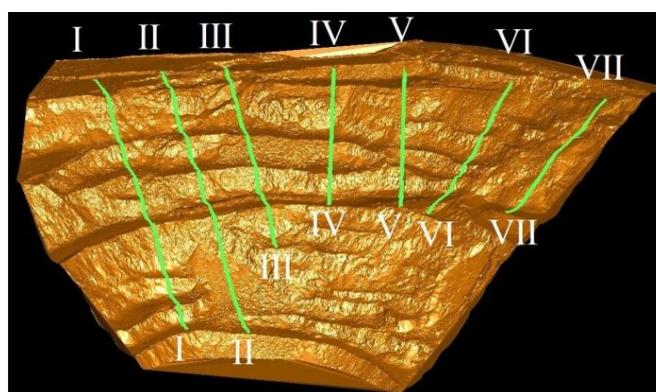
Результаты сканирования 05.11.15 г.

Результаты сканирования 26.05.16 г.

Рис. 4. 3D модель оползневого участка

Результаты лазерного геосканирования представлены в виде 3D модели исследуемого участка с VII сечениями в период с ноября 2015 г. по май 2016 г. (рис. 4) [40].

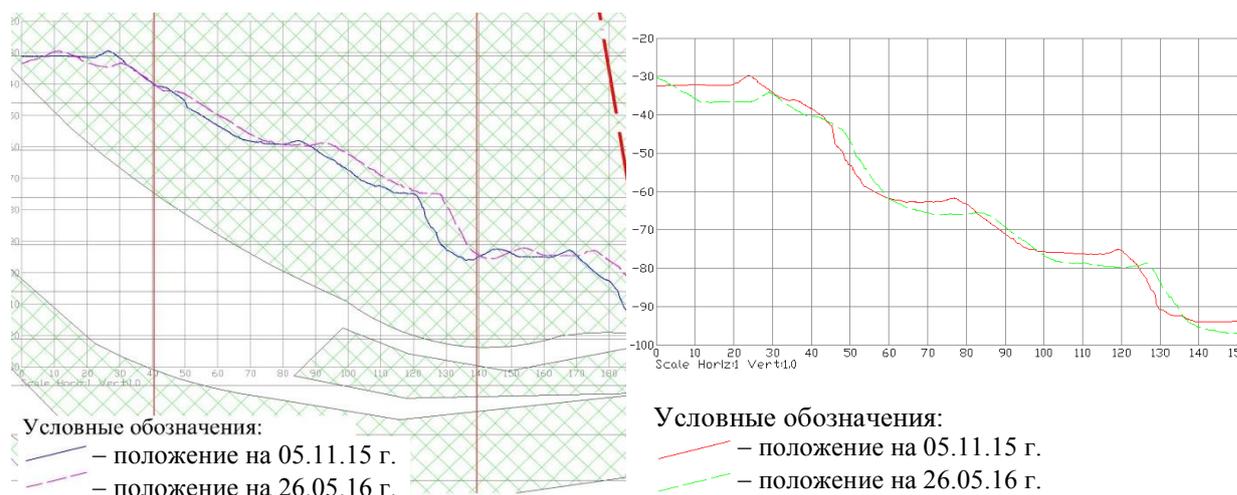
Продольный профиль оползневого участка по сечению III-III

Продольный профиль оползневого участка по сечению IV-IV

Рис. 5. Сечения, построенные на оползневом участке по результатам обработки лазерного

Наблюдения по поперечным сечениям показали, что значительные смещения происходят по второй, третьей и четвертой линиям (рис. 5).

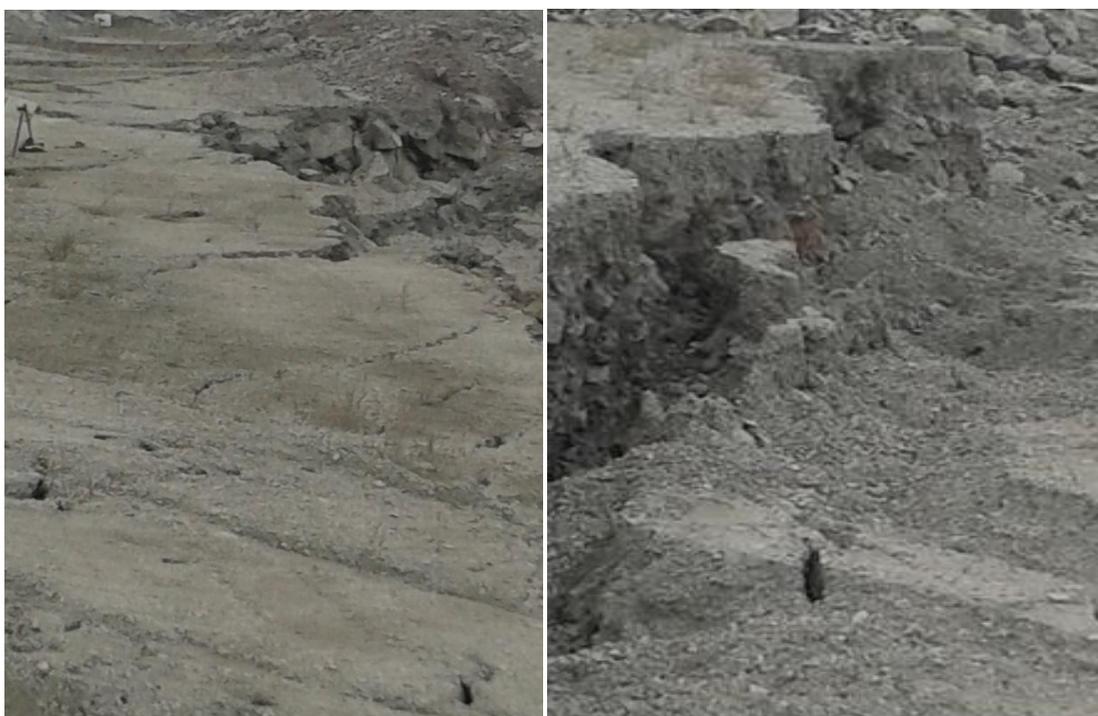
Рис. 7. Линия отрыва с оседанием площадки более 5 м на горизонте –30,0 м

Анализ результатов исследований по инженерно-гидрогеологическим изысканиям и данных инструментальных наблюдений на основе внедрения инновационных технологий позволил спрогнозировать развитие деформаций и принять меры по предотвращению аварийной ситуации (рис. 7).
